## Integrating Spatiality in Urban Facades through the Reuse of Cultural Heritage Elements in Dar es Salaam City Centre

**Keywords:** *Integration; Disintegration; Refurbishment; Urban Facades and Architectural Conservation*

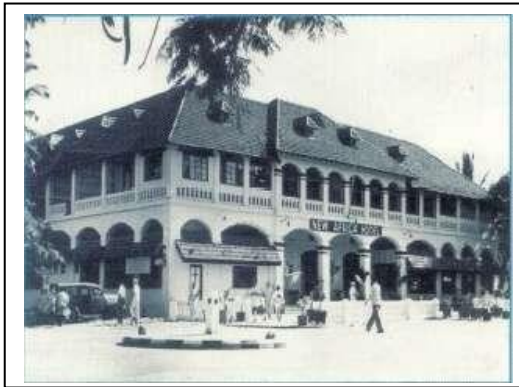
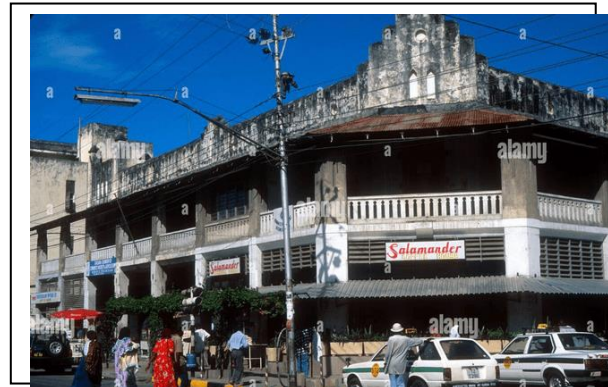
Figure 1 (left) is a picture of New Africa Hotel during British period which had values of characters hardly found in today's development was demolished to give room for current multi-storey modernist structure and Figure 2 is a picture of demolished Salamander Corner House[1], with rich historic architectural elements, demolished in 2010 there is hope that the coming building will have no such qualities.

Two buildings above were demolished to give room for the erection of multi-modern structures. The successor did not conform or hire some elements present before, as the following picture of New Africa Hotel (new or successor of the previous one) found in the book titled 'Dar es Salaam a National City with a character and a history: A pictorial presentation' edited by Msemwa, P. et al 2005: 24

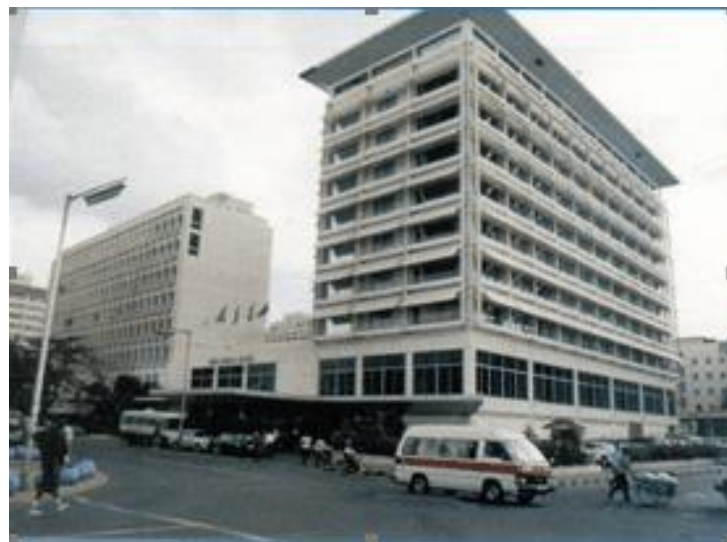
Figure 3 centered above is a picture of New Africa Hotel currently found which replaced the former New Africa Hotel in figure 1 above.

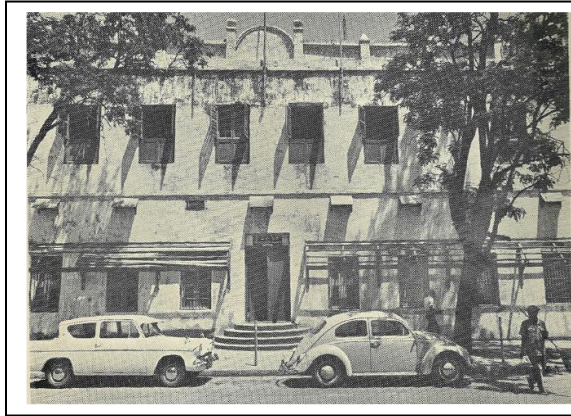
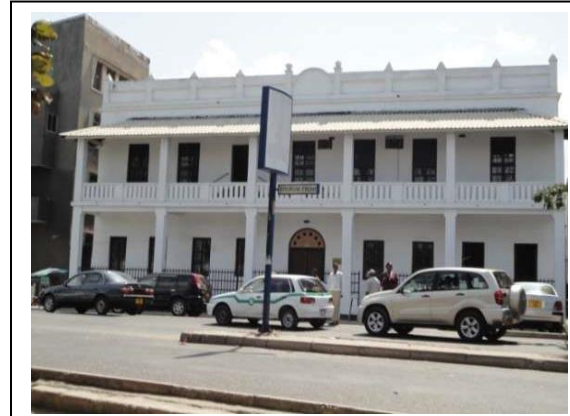
in below picture after intervention. Also comparison can be made between the below two pictures to reveal their differences. A distinction is clearly seen as a result of intervention (integration) in the right picture figure 8, added elements blended well with existing building fabric to make it more functional and pleasing to see.

Figure 5 (left) is a photograph of a White Fathers building before alteration while figure 6 (right) is a photograph of a White Fathers building after the addition of columns (which created veranda at ground floor and balcony at the upper floor), decorated balustrades and a gentle slope pitched roof for balcony at the first floor

Positive effort taken to refurbish White Fathers building (in part 4.1.1.1 above) whereby addition of columns which created veranda at ground floor and balcony at the upper floor, decorated balustrades and gentle slope pitched roof merged well with existing situation before the inclusion of the aforementioned elements and old fabric took place contributing to the Integration of elements and Object.

Inclusion (integration) of veranda and balcony to white father's house during its refurbishment was of great value. Added veranda and balcony associated with colonnade without forgetting concrete floor slab between the floors (ground and first floor) harmoniously connected with existing building fabric.

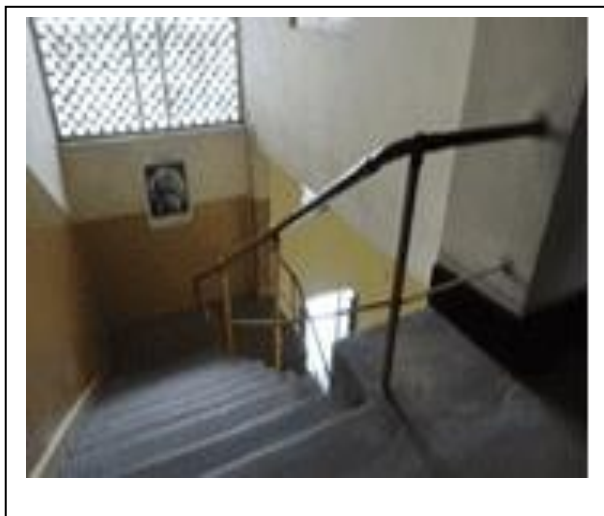
Figure 7 (left) is a photograph showing added balustrade to staircase (element value) and figure 8 (right) is a photograph which modified window whereby hardwood louvers were replaced with glass shutter and steel bars added to take care issue of security. (element value)

Introduction of balustrade and handrail as described in figure 7 helps to strengthen security and support to users while using stairs. This positive effort as integration approach at element level aimed to make the White Fathers building to be users friendly.

Conservation actions took place in white fathers building during its refurbishment is something to be commended. The intervention activities of adding balustrade and handrail, replacing hardwood louvred shutters with glass and steel bars were highly appreciated. Because building functionality and security aspects were improved.

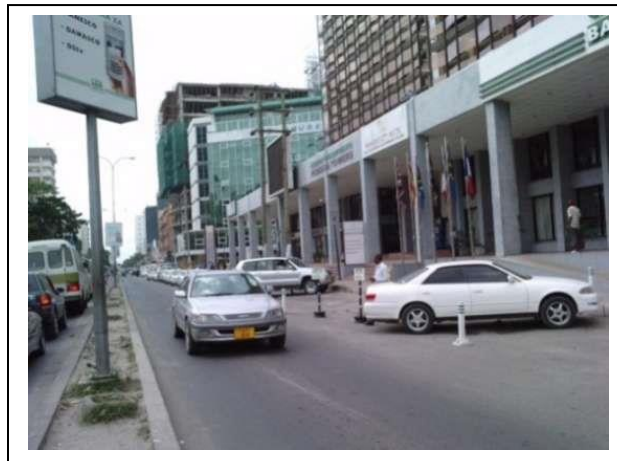
Figure 9 (left) is a picture of Benjamin William Mkapa Pension Towers building found along Azikiwe Street being recent development with modern stylish integrated elements most prevailed in the past.

Lines of columns (colonnades) can clearly be seen from the pictures which creates arcades a useful element for shading purposes and others like window shopping.

The same can be experienced in new development/project as the case of Benjamin William Mkapa Pension Towers. An arcade and colonnade are part of modern or current development rich in concrete, steels and curtain windows.

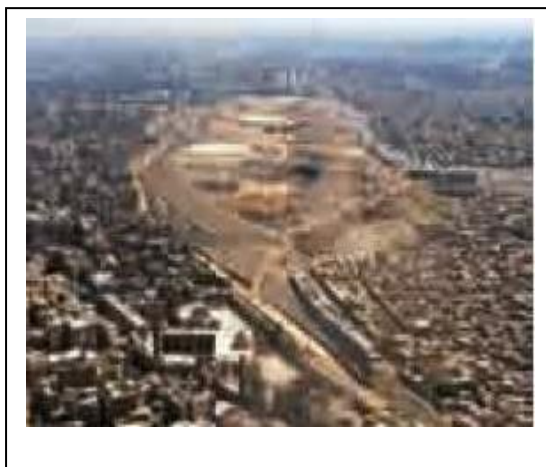
Figure 10 (left) is a photograph of a of Azhar Park site before an intervention while figure 11 (right) is a photograph of Azhar Park of Cairo after development.

*Left picture is an aerial view of Azhar which shows the site before the intervention of the Aga Khan. As the image imply, the Park has come today to be considered a veritable oasis in the city for many residents, while right picture is also an aerial view of Azhar Park shows the Hilltop Restaurant in the foreground and the Lakeside Cafe at the top of the image. (Seite 86 & 90)*

Measures taken to revive or renew an abandoned site used for refuse collection for many years to become one of important green open space cannot pass without being appreciated. The move of reviving the abandoned site of Azhar to join it with the rest of the City is amounting to realization of integration at context level.

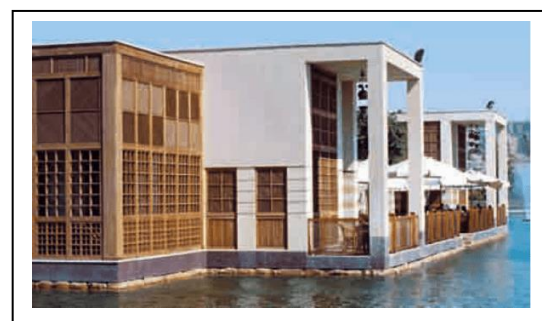
Figure12 (left) is a view of Hilltop Restaurant in Azhar Park while figure13 (right) is a view Lakeside Cafe in Azhar Park

Views of the Hilltop Restaurant in Azhar Park, Cairo, by Rami El Dahan with Soheir Farid. Calling on Fatimid tradition, the architecture is intending to respond both to its location and to the history of Egyptian capital, on the left picture while on the right is The Lakeside

Cafe in Azhar Park, Cairo, by French Architect Serge Santelli strikes a somewhat more modern note than the Hilltop Restaurant. It is situated on an artificial lake created to assist with the irrigation of the Park itself. (Seite 93&94)

Development of vacant abandoned site used for refuse collection for many years as described above added value of Cairo City. Integration aspect at context level of Cairo City was realized by urban renewal measures taken to develop the abandoned land used for collection of rubbish to create Azhar Park of Cairo which merge with the rest of Cairo to become one of the beautiful City. Two projects resembles in their building height, flat roofs employed and uses arcades and columns. They also differ; domes are seen in buildings with arched openings. Colonnade is dominating in Hilltop Restaurant compared to

Lakeside Café. Generally, architectural elements are the ones which cause the difference of two buildings. Historic architectural elements are employed in the Hilltop Restaurant, while Lakeside Café is belonging to modern stylish.

Hilltop Restaurant and Lakeside Café are two projects found in Azhar Park of Cairo being outcome of its urban renewal. As mentioned earlier Hilltop Restaurant is rich in historic architectural elements while Lakeside Café is mostly of modern stylish.
